Insulating Biomaterials N01-NS-2-2347

Fourteenth Quarterly Progress Report January-March, 2006

Neural Prosthesis Program

InnerSea Technology

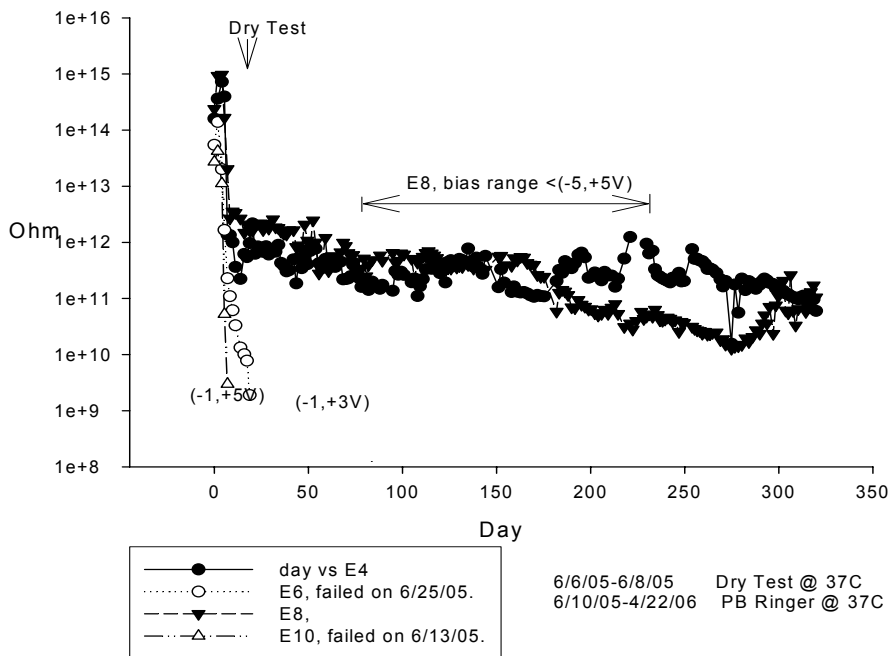
LCPLCP050404#1_7/8"
55/55u traces

LCP-LCP samples are IDE on LCP insulated with another layer of LCP. After few days dry test, samples began wet test in PB Ringer. The experiment results show that in general the samples with 30 μ /30 μ traces fail faster than 55 μ /55 μ TT devices. Also, the samples with shorter triple tracks section (1/2" and 7/8"TT) often survive longer than the samples with longer TT (1 1/4"). Up to 4/22/06, most of LCP-LCP devices have failed and LCPLCP050404#1_7/8" is the only sample currently continuing its test. While the cause of failure is not obvious for some devices, microscopic exam does show pinhole defects and lint contamination on the others (e.g. LCPLCP050404#3 & LCPLCP050404#1_500.) The experiment results are summarized in following plots.

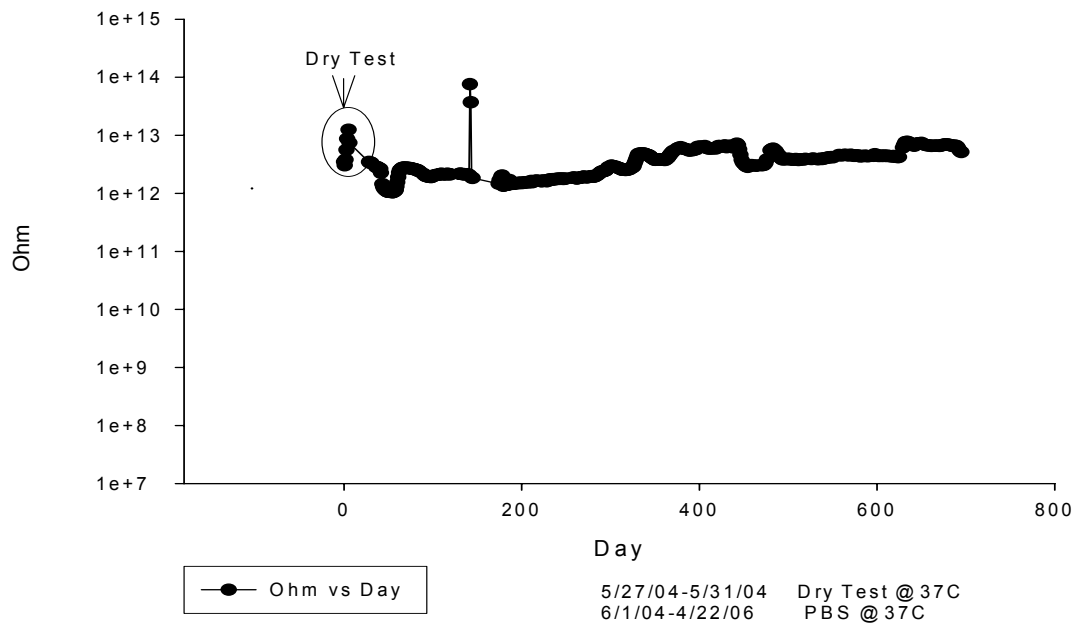
RSHFV3D3TBP041204B1(E4)
5u film @ condition 1

5 μ film deposited at condition#1 ($P=300\text{mT}$, $T_f=500^\circ\text{C}$, $T_s=60^\circ\text{C}$) has the “wrinkled” surface morphology. As indicated in Sigma plots, after almost 23 months soaking, five out of eight samples, RSHFV3D3TBP041204B1(E4,8,10)&B2(E6,10), keep the resistance at $10^{12}\Omega$. The other three, RSHFV3D3TBP041204B1(E6)&B2(E4,8), showed an asymmetrical IV since the beginning of the wet measurement, which indicated electrochemical corrosion process undertaking due to exposure of Si substrate at defects in passivation layer. Si oxidizes when bias negatively and reduces at positive sweep, therefore devices show more hermetic at the negative range (typically $10^{11}/10^{12}\Omega$) and high leaky at positive bias (typically $10^9\Omega$). Microscopic exams taking before and after test verified most plane(1,1,1) corrosion sites caused by defects in the deposited silicone films of RSHFV3D3TBP041204B1(E6) & B2(E4,8).

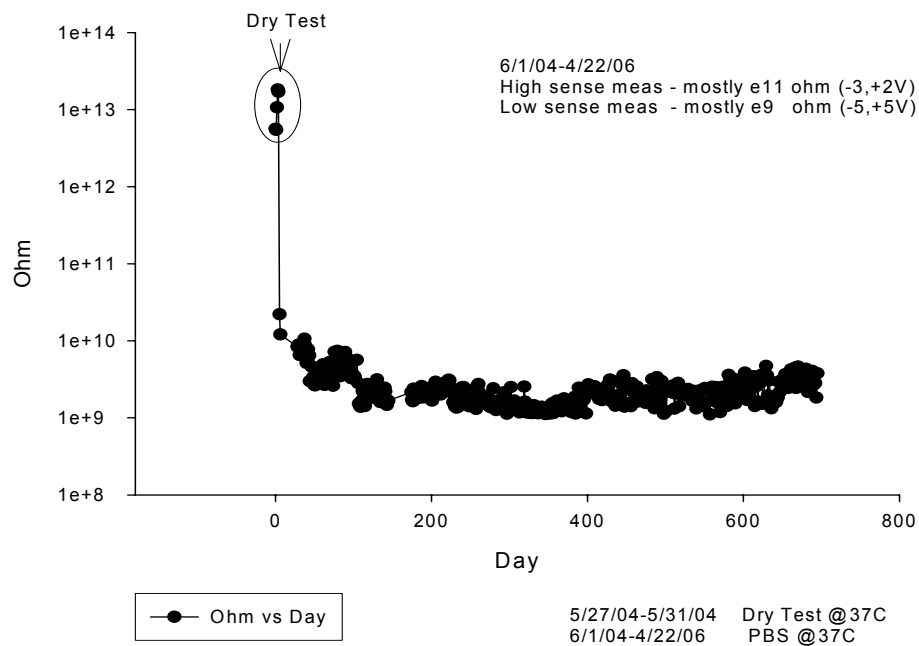
RSHFV3D3TBP041204B1(E6)
5u film @ condition 1

RSHFV3D3TBP041204B2 (E4) was terminated on 8/12/05 and RSHFV3D3TBP041204B1(E6) & B2(E8) were terminated on 4/22/06. The pass tests for rest 5 μ samples are continuing.
